New York State Department of Transportation

Yellow Flag NB2228W023

BIN: 1065318
Feature Carried: 278I278IX2M23027
Feature Crossed: 6TH AVENUE
Orientation: 8 - NORTHWEST
Region: 11 - NEW YORK CITY
County: KINGS
Political Unit: City of NEW YORK
Approximate Year Built: 1962
Posted Load Matches Inventory : Yes
Bridge Load Posting (Tons) : Not Posted for Load
Primary Owner: New York State Department of Transportation
Primary Maintenance Responsibility: 12 - State - Subcontracted to another Party
Typical or Main Span Type: 3 - Steel, 02 - Stringer/Multi-Beam or Girder
This Bridge is not a Ramp
Number of Spans: 322

Location: Span 256 G4 at Pier 256

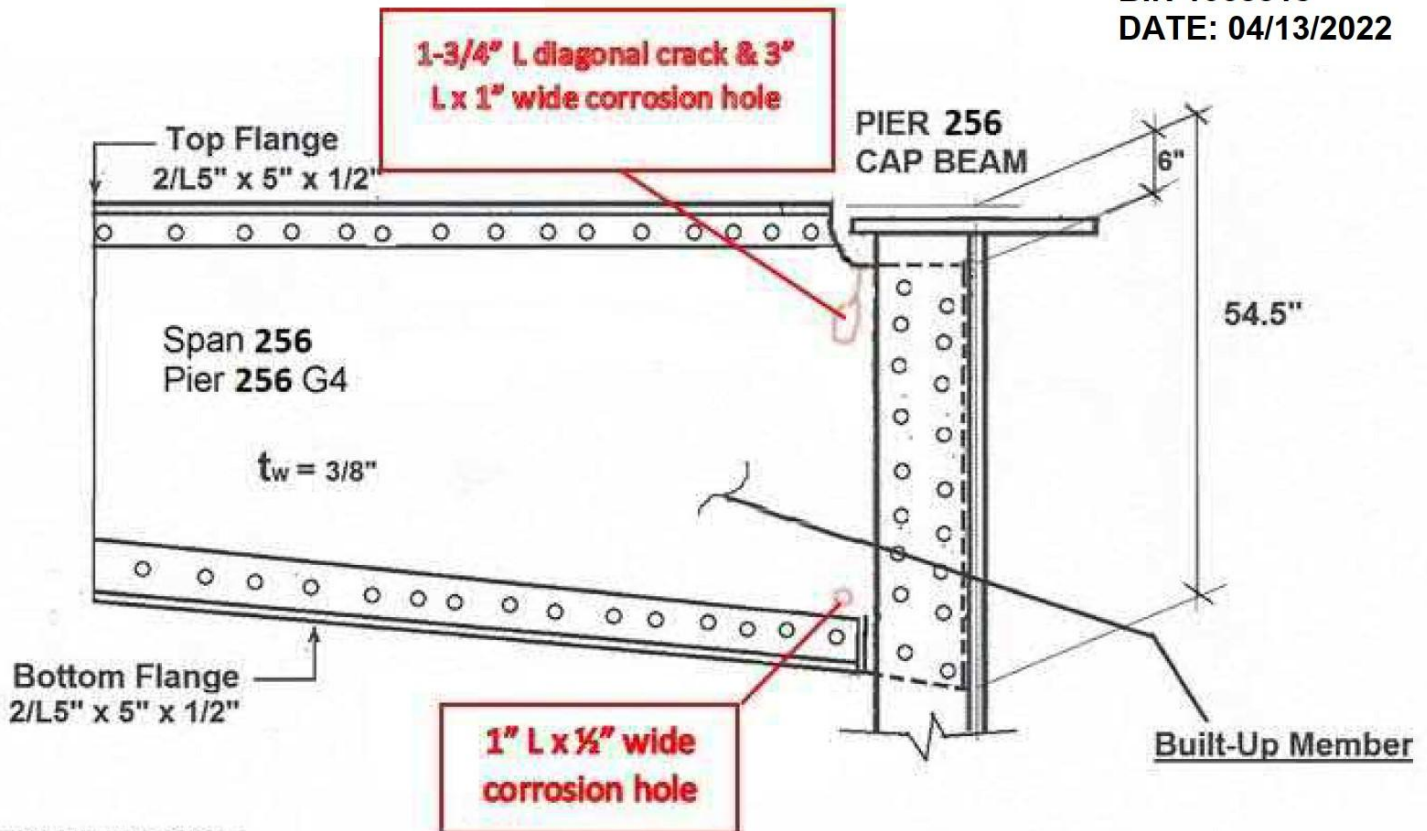
Photo Number: 2

The affected member Girder G4 is a load path redundant built-up steel girder consisting of varying web depth x 3/8" thick and two equal leg angles (L 5" x 5" x 1/2") for the top and bottom flanges (Photo 2). The spacing between Girder G3 and G4 is 6'-11" on center and 3'-9" on center from G5 (Photo 1).

**Built-Up Member Properties**

Vary depth web: 54.5" b-to-b Ls @ Piers 255 and 256 and 33" @ midspan

Web thickness = 3/8"

Bottom and Top Flanges are two equal leg angles L 5" x 5" x 1/2"

Span 256, Girder G4 at Pier 256
Elevation (Right)

Attachment Description: Sketch of G4 at Pier 256

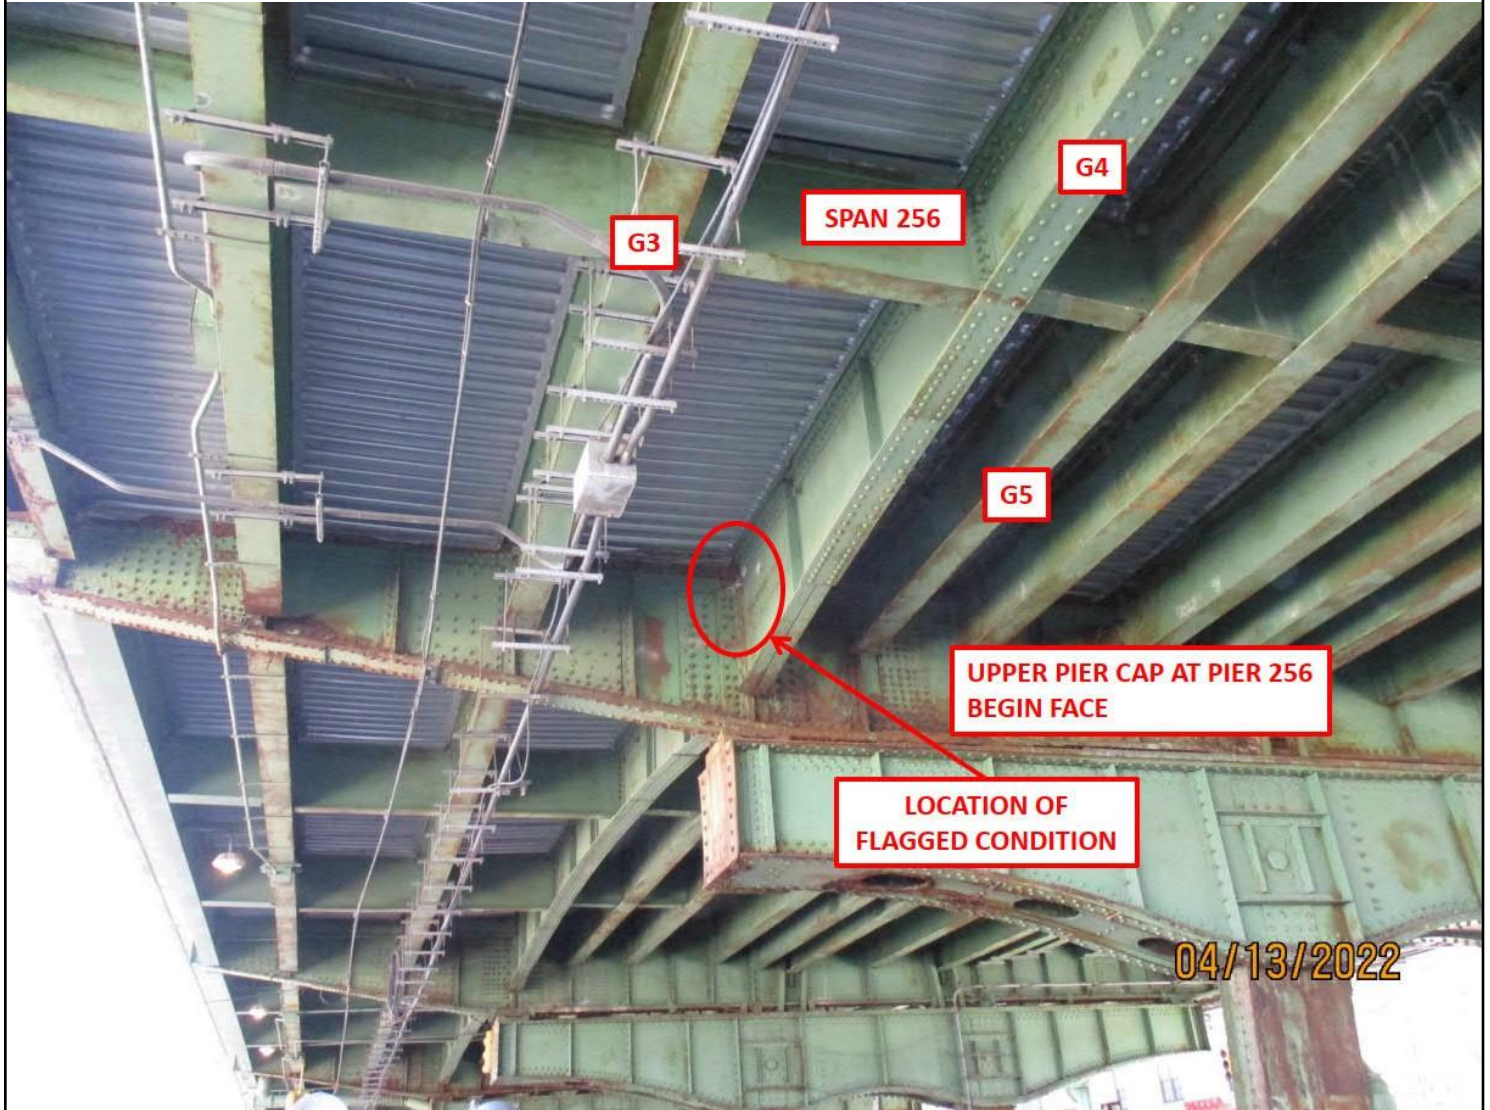
Photo Number: 3

Description: The web of the girder at the upper cope has a 1-3/4" long diagonal crack that extends into a 3" L x 1" W corrosion hole. The lower web above the bottom flange angle vertical leg has a 1" L x 1/2" W diameter corrosion hole. (Photos 3, 4 & 5).

Attachment Description: Span 256 G4 at Pier 256 – General framing plan of flagged location. Looking End.

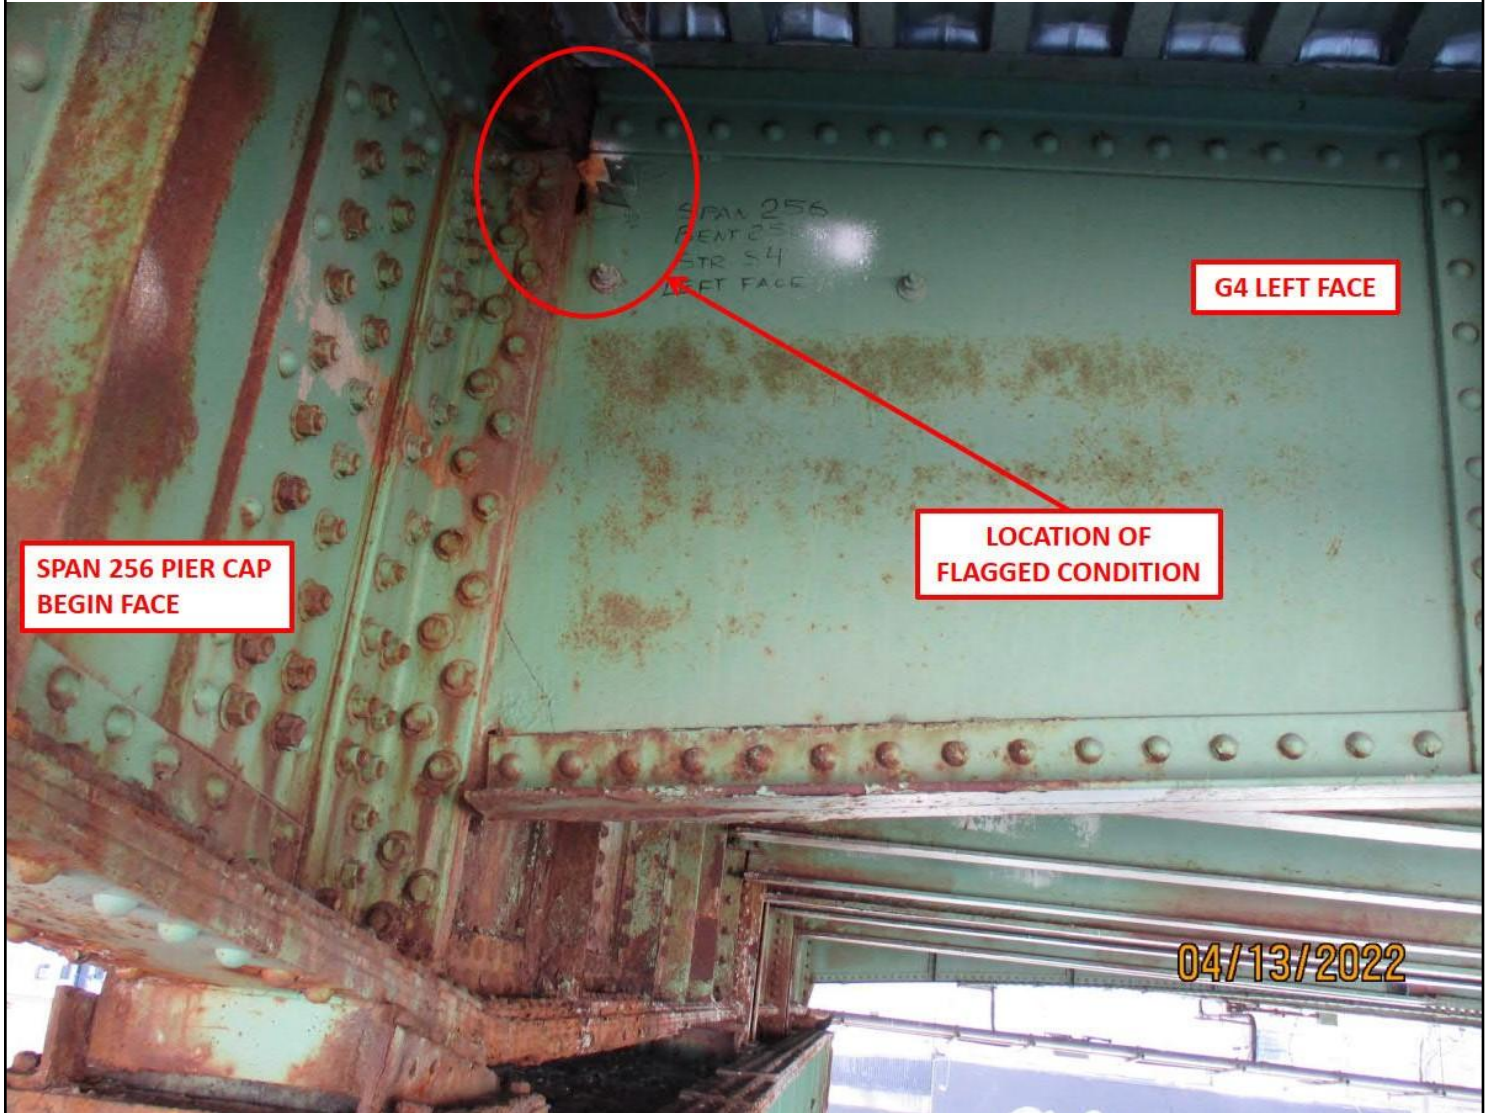
Photo Number: 4

Attachment Description: Span 256 G4 at Pier 256 – General view of flagged location. Looking End Right.

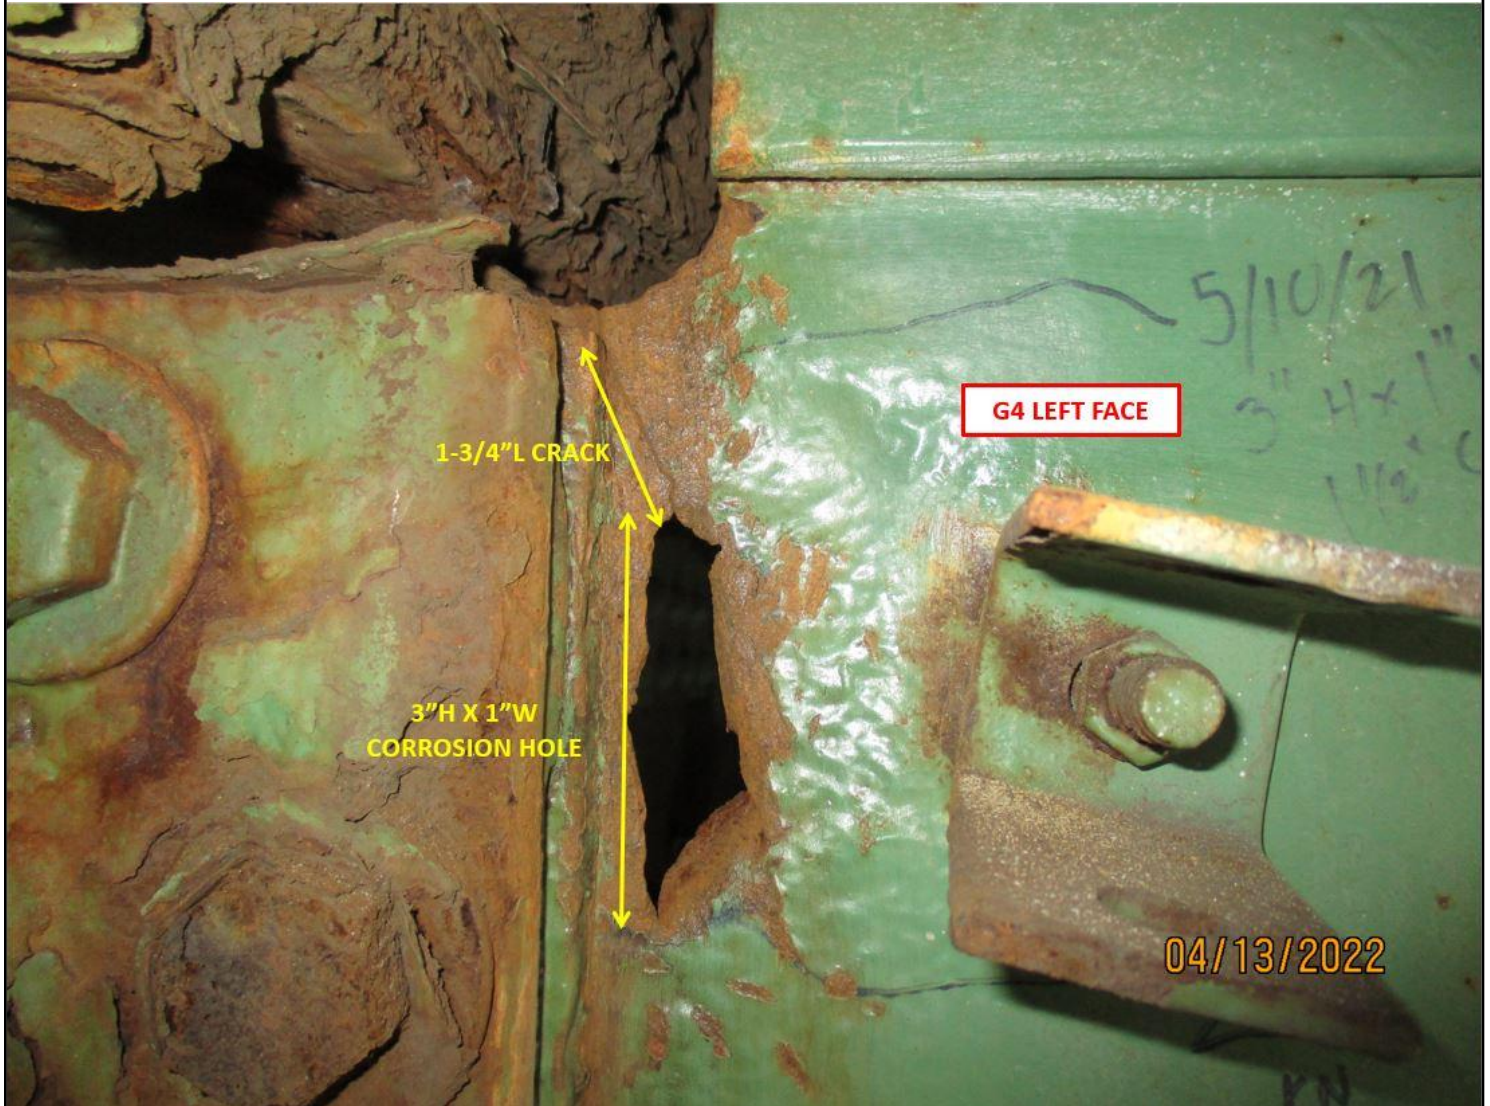
Photo Number: 5

Attachment Description: Span 256 G4 at Pier 256 – Close up view of 1-3/4" long diagonal crack at upper cope and 3" H x 1" W corrosion hole at end of crack before dye test. Looking Right.

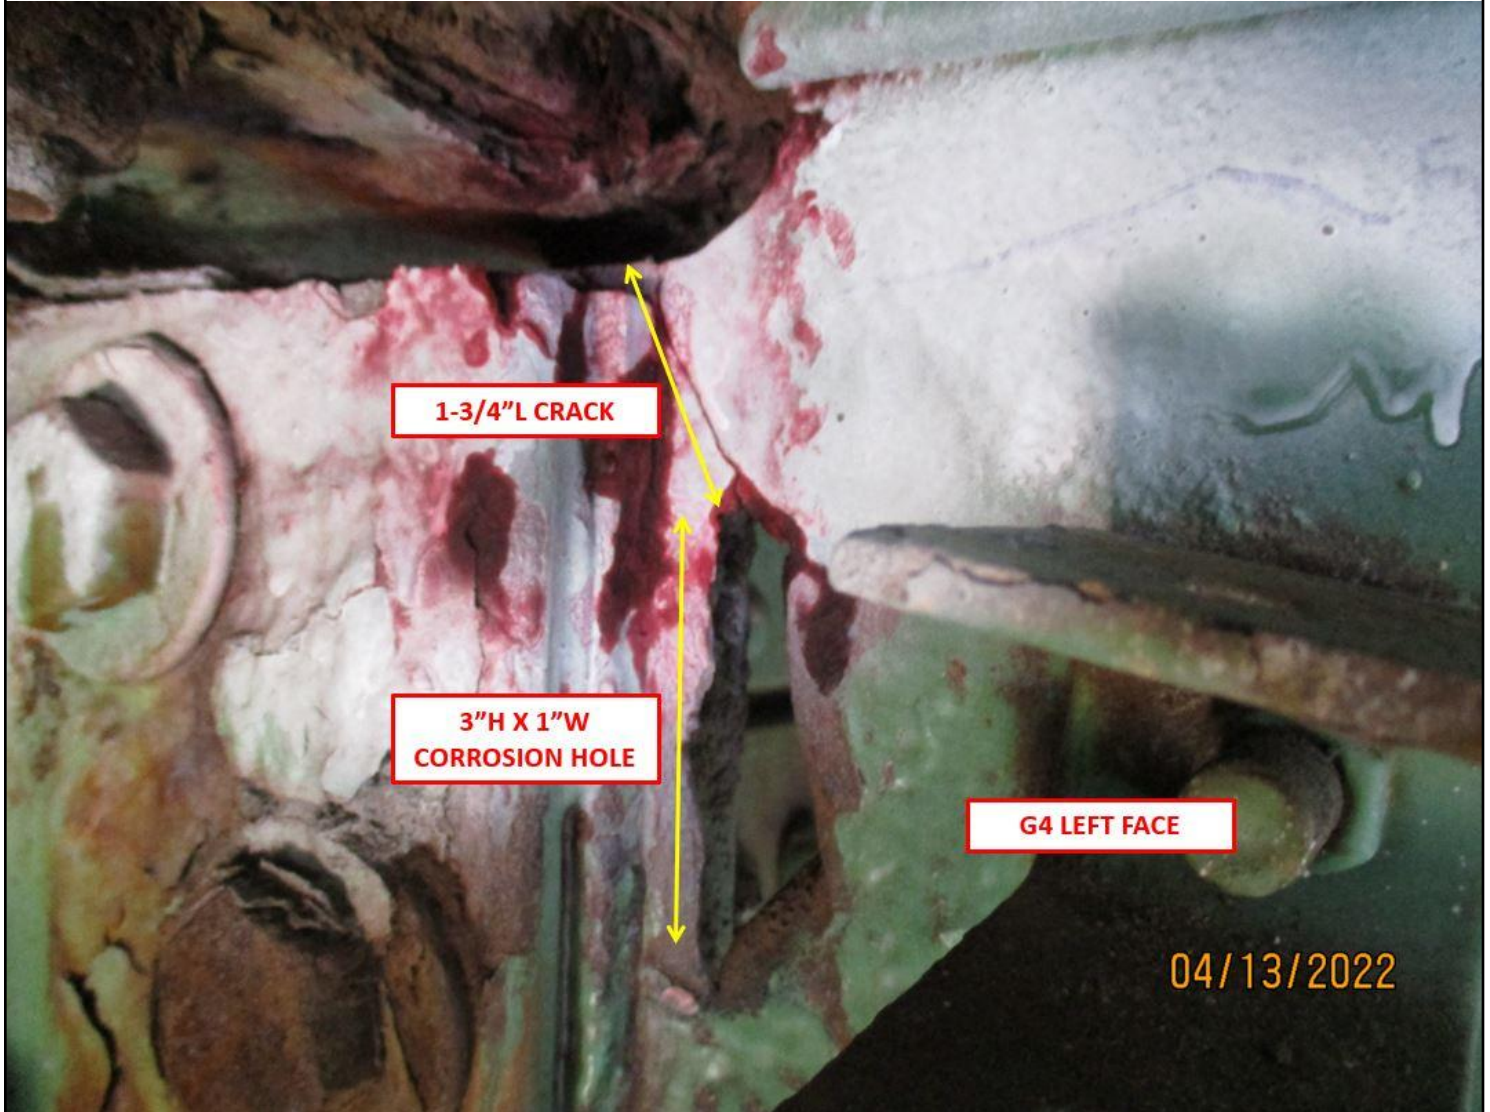
Photo Number: 6

Attachment Description: Span 256 G4 at Pier 256 – Close up view of 1-3/4" long diagonal crack at upper cope and 3" H x 1" W corrosion hole at end of crack after dye test. Looking Right.

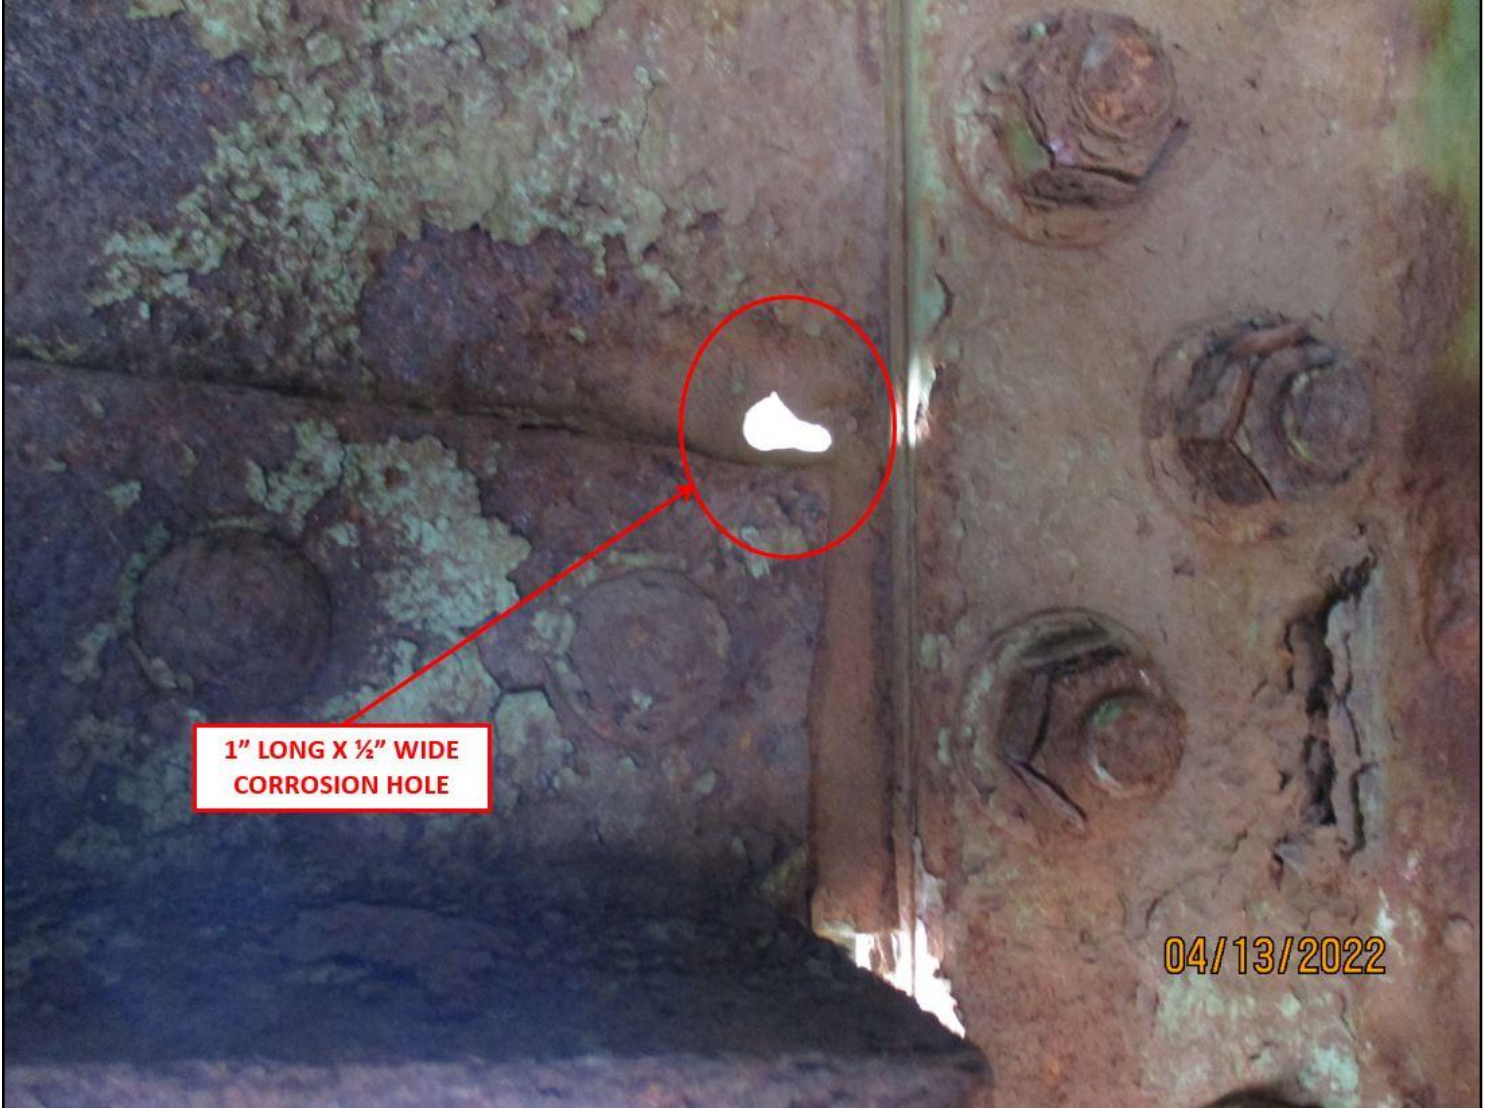
Photo Number: 7

Attachment Description: Span 256 G4 at Pier 256 – Close up view of 1" long x 1/2" wide corrosion hole at lower web above bottom flange angle. Looking Left.
